LRT 200, LRT200-2

Troubleshooting Vacuum Bottle Failure Alarms

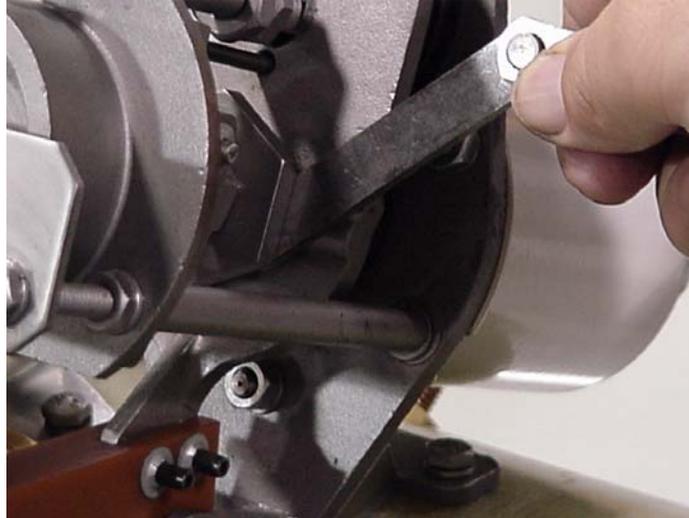
Fig. 1: Checking the interrupter bottle pre-travel

- A. Verify the vacuum interrupter pre-travel by measuring the gap between the upper actuator arm and the drive nut (refer to Fig. 1). This gap should be .125" +/- .010" with the vacuum interrupter in the closed position. This insures the drive nut strikes the upper actuator arm with enough force to throw the vacuum interrupter open.

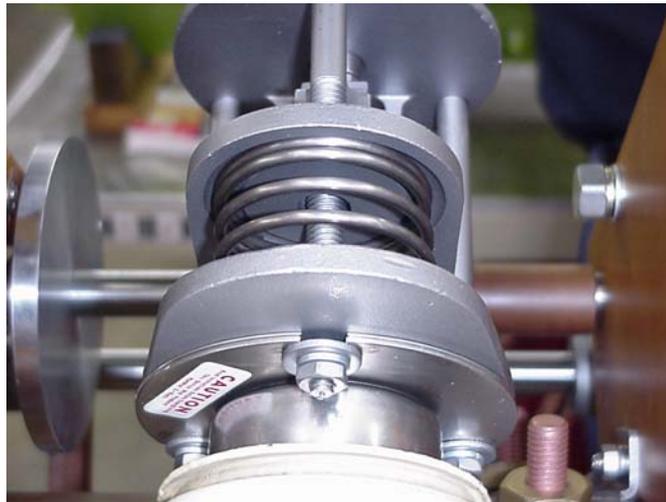
Fig. 2: Alignment of stud through upper actuator arm

- B. Carefully inspect the alignment of the hole through the upper actuator arm with respect to the 5/16" threaded stud going through it (refer to Fig. 2). If this stud is not centered in the hole of the upper actuator arm, the arm can bind on the threads of the stud and prevent the interrupter mechanism from operating freely. If this occurs the vacuum interrupter should be replaced.

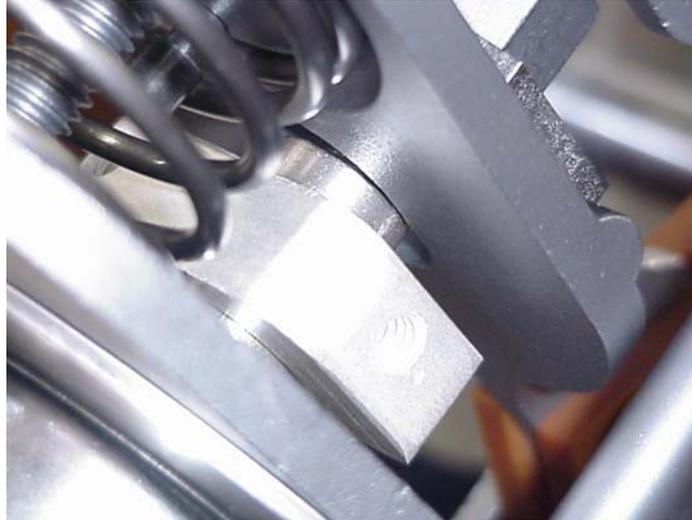
Fig. 3: Alignment of vacuum interrupter shaft through upper actuator arm

- C. Carefully inspect the alignment of the movable shaft on the vacuum interrupter where it passes through the hole in the upper actuator arm to insure there is no binding between the parts (refer to Fig. 3). If the vacuum interrupter is not centered through the hole in the arm and is binding during operation the vacuum interrupter mechanism should be replaced.

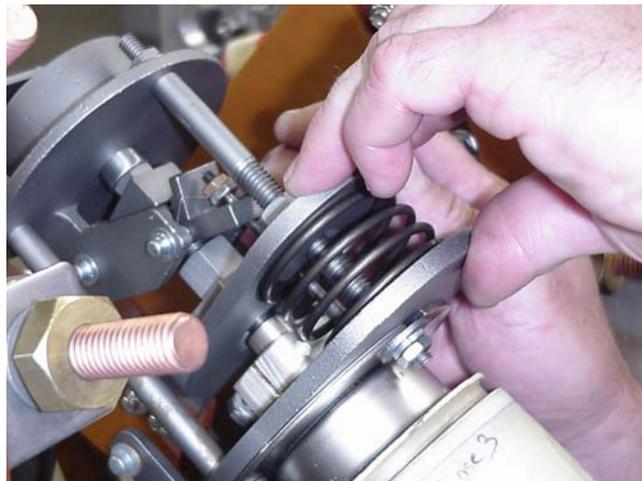
Fig. 4: Operating the vacuum interrupter assembly by hand

- D. With the LTC off position and the vacuum interrupter open, release the latch block on the interrupter assembly with one hand while squeezing the upper actuator arm towards the interrupter mounting bracket to close the vacuum interrupter (refer to Fig.4). Do this on all three phases several times to insure the vacuum interrupter operates freely. Any signs of binding or slow operation should be investigated further and / or replacement of the suspect vacuum interrupter assembly be performed.

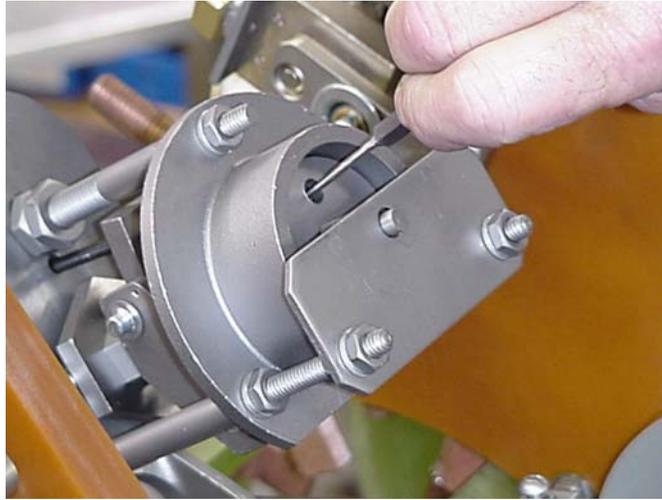
Fig 5 Checking Dashpot Baffle Plate Movement

- F. Verify the dashpot baffle plate is not binding by inserting a small rod through the holes of the dashpot assembly and push down on the baffle plate (refer to Fig 5). If this plate is binding and not moving freely sluggish operation of the vacuum assembly can occur possibly resulting in vacuum failure alarms.

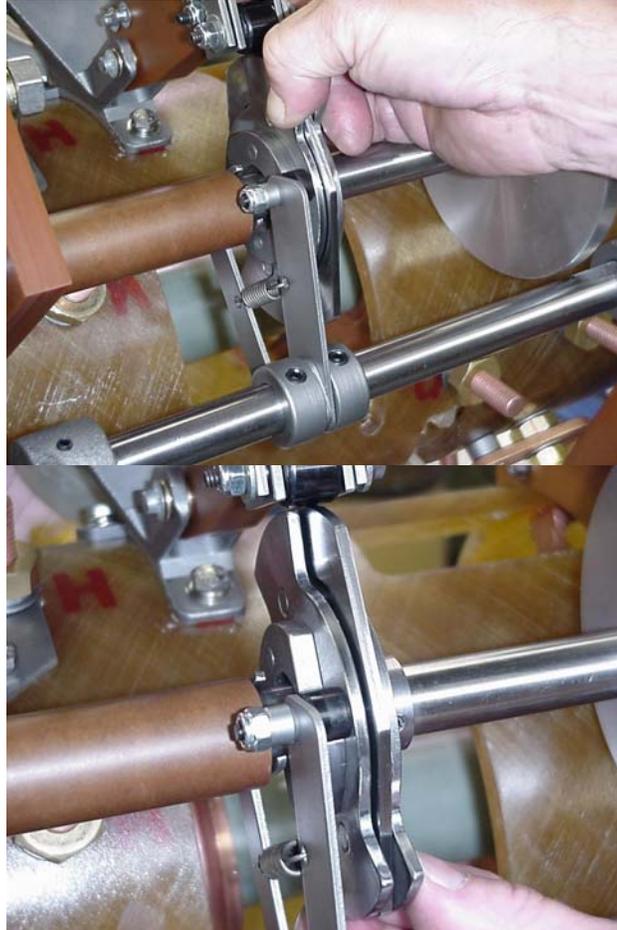
Fig. 6 & 7: Verifying auxiliary cam operation

- G. Verify the auxiliary cam and roller on the dual slope cam assemblies that control the opening and closing of the interrupter assemblies operate freely. Push / pull auxiliary cam with the LTC on position to insure it moves freely and the follower roller stays within the “V” shaped portion of the auxiliary cam (refer to Fig 6 & 7). Binding of the auxiliary cam against the center cam can result in the interrupter not opening properly.
