FPE MODELS TC-525 & TC-546 SPRING DRIVE TEAR DOWN, MAINTENANCE AND REPAIR

In this white paper, we will discuss tear down, maintenance and repair of the FPE TC Series spring drive mechanisms. We stock many of the components that will be discussed and for those who might be interested, we offer full tear down and overhaul services for each of the FPE TC Series spring drive mechanisms. As a part of the discussion, a comparison of the models that were produced will be offered and the key differences in the models will be highlighted and described. The information we provide will help to ensure you properly identify your model and are positioned to recognize and procure any replacement components that you ultimately need as a result of your inspection. Key activities that should be completed, including major items that should be inspected and maintained, will be listed and discussed. Helpful tips to aid in tear down and inspection will also be shared.

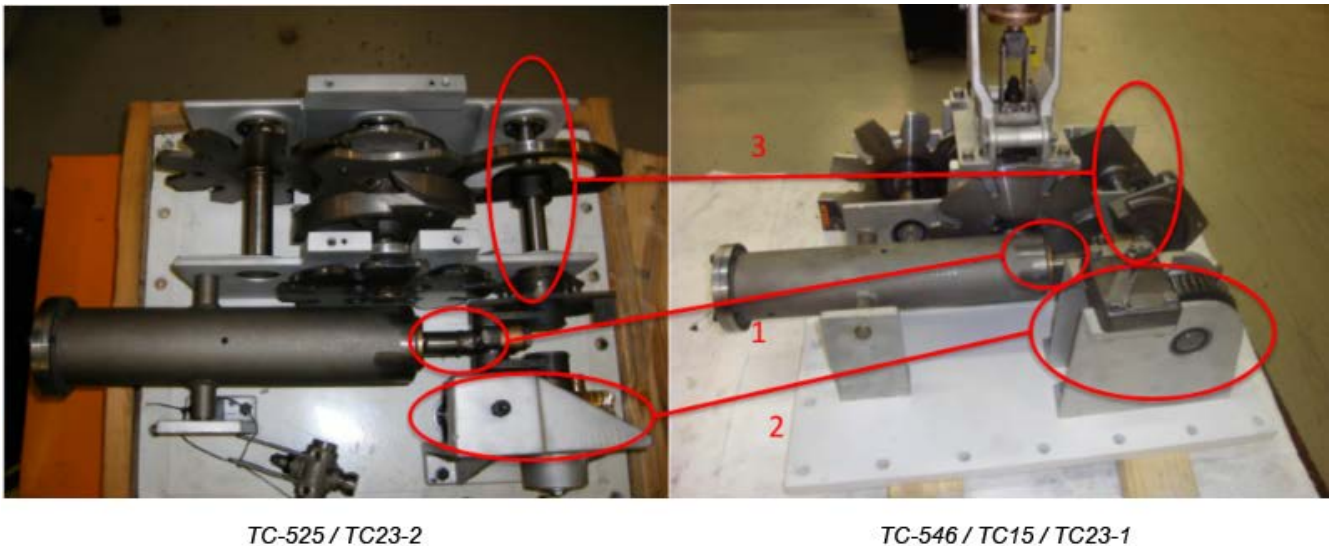
Figure 1 above depicts a top view of each variant in which three main differences in the two models are circled in red and numbered. Below is the description of each of the numbered differences:

1. Drive spring barrel assembly for the TC-525 has a 1" diameter shaft, while the same shaft on the TC-546 has a 3/4" diameter.
2. Dimensions and materials of the vertical drive shaft, worm gear and worm gear support structure are different.
3. Dimensions and materials of the lock plate and first shaft assembly are different.

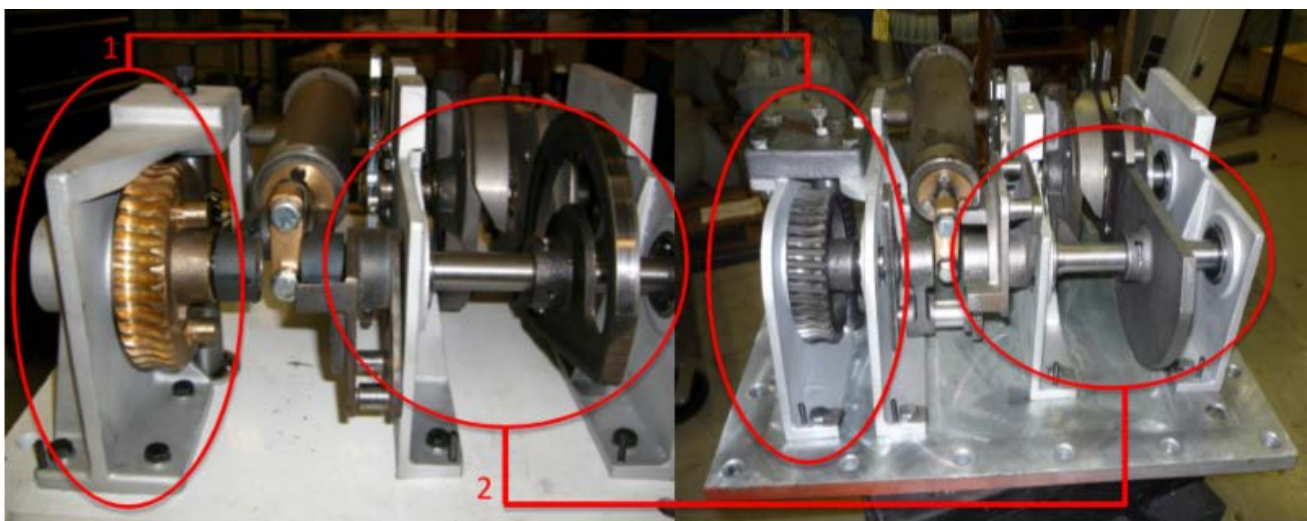
Figure 2 above provides a left side look at both variants, resulting in another view of two of the three main differences in the models. The differences are circled in red and numbered. Below is the description of each of the numbered differences:

1. Dimensions and materials of the vertical drive shaft, worm gear and worm gear support structure are different.
2. Dimensions and materials of the lock plate and first shaft assembly are different.

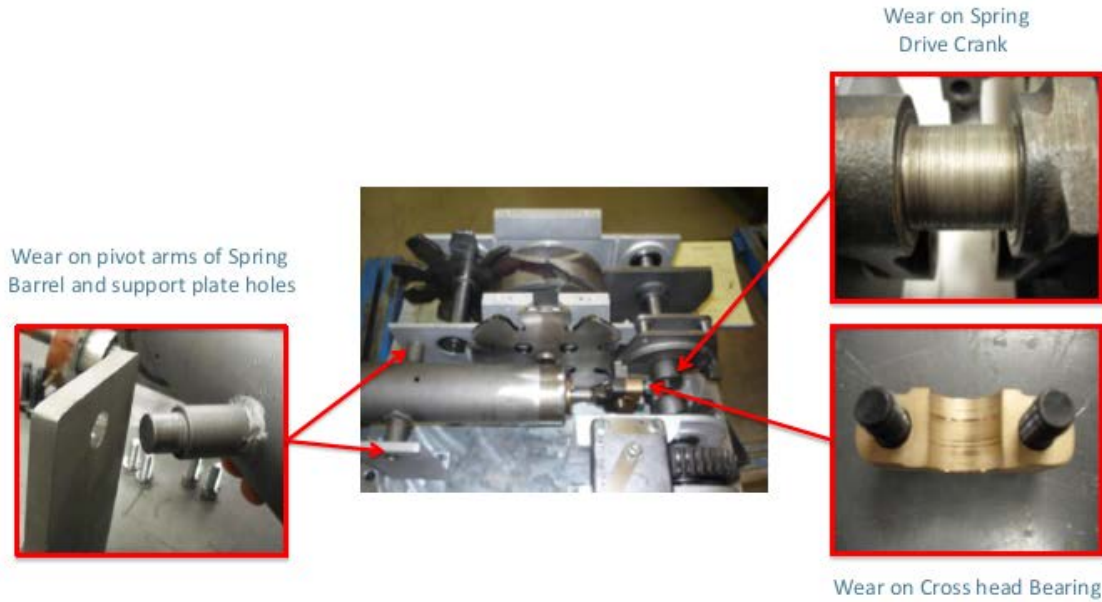
Figure 3: Wear Patterns on Key Components

Figure 3 above shows the locations and types of wear that can occur on the spring barrel mount and support plate holes. Typical wear on the spring drive crank and the cross head bearing is also depicted.

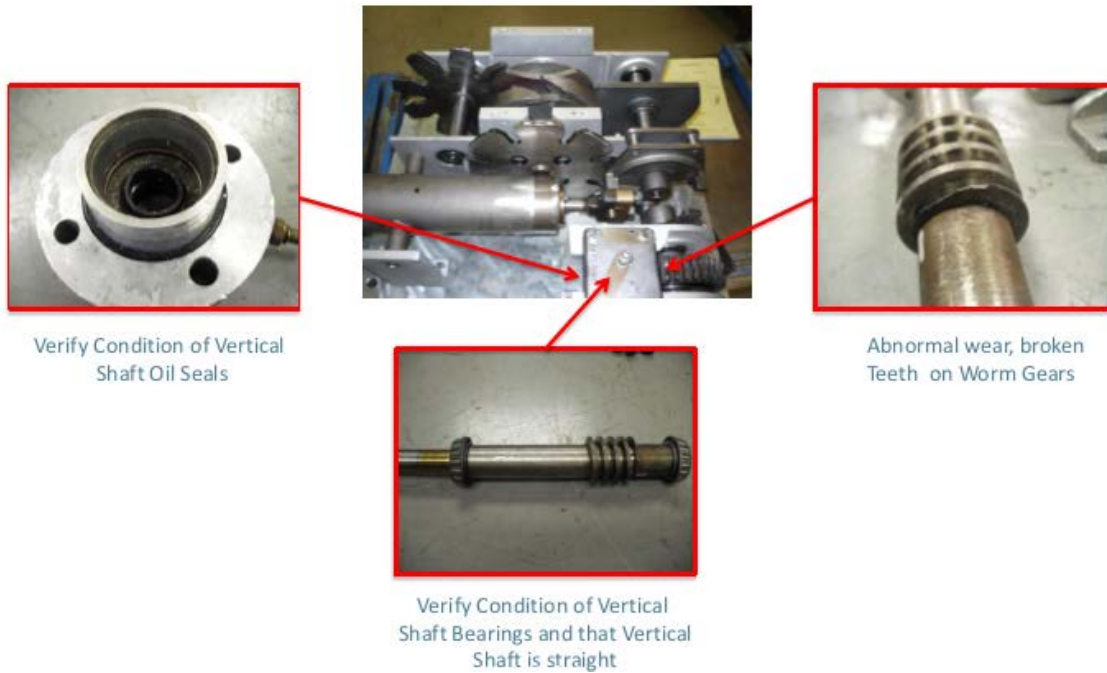
Figure 4: Inspection Points on Main Spring Drive Barrel Assembly

Figure 4 above provides visualizations of each of the major inspection points on the main spring drive barrel assembly. Brief descriptions of the individual items are included for reference.

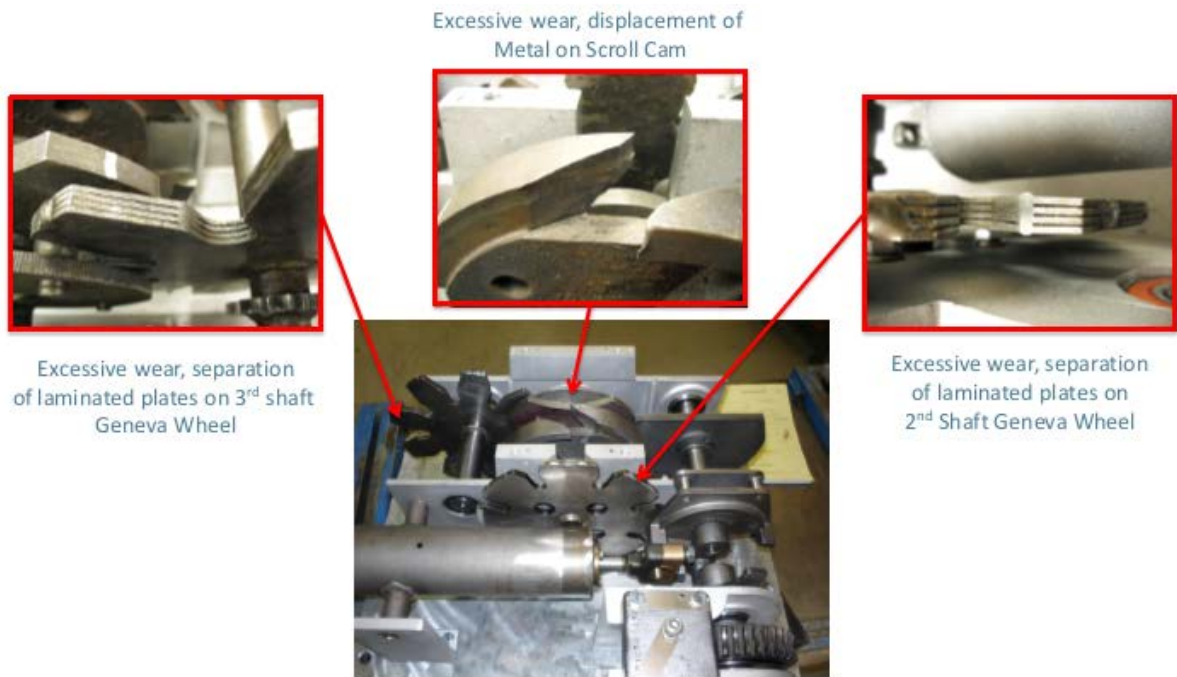
Figure 5: Wear Patterns on Geneva Wheels and Scroll Cam

Figure 5 below shows the locations and types of wear that can occur on the Geneva wheels and scroll cam. Excessive wear and separation of the laminated plates on both Geneva wheels are shown. *NOTE: The scroll cam depicted in the picture has excessive wear.*

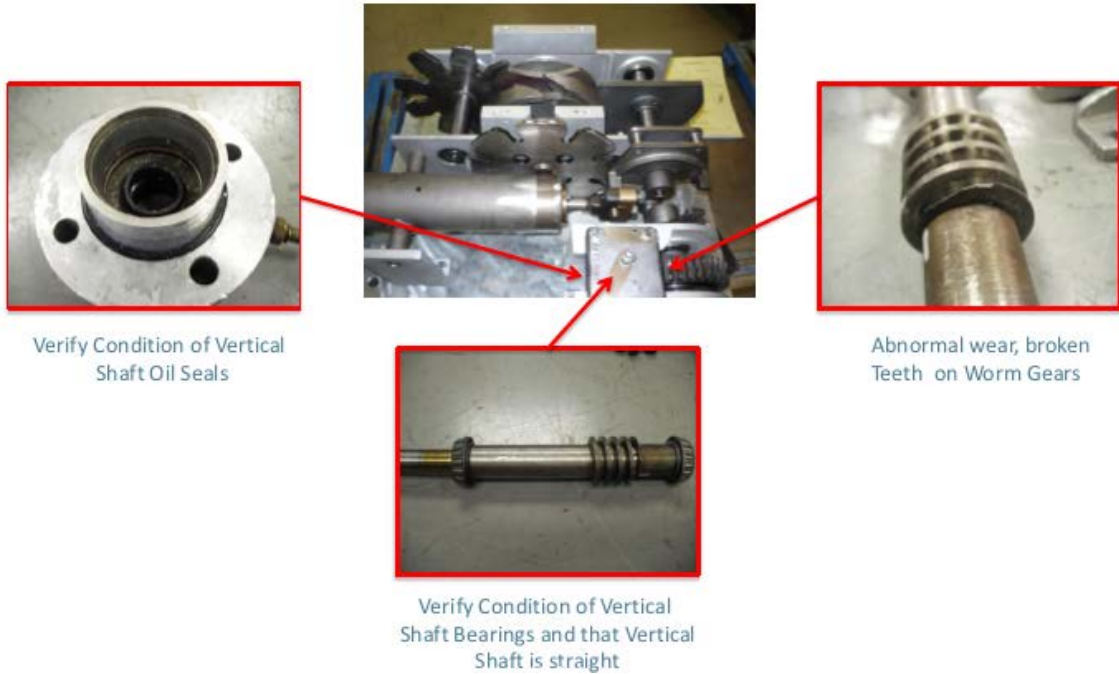
Figure 6: Wear Patterns on Vertical Shaft

Figure 6 below shows the locations and types of wear that can occur on the vertical shaft. Pay special attention to worn or broken teeth on the worm gears. Also, inspect the area where the shaft seals contact the shaft to ensure that grooves have not worn into the shaft.

Ensure the vertical shaft is straight and verify condition of the oil seals. Refer to Figure 7 below for detailed information on the two types of vertical shaft oil seal assemblies that were used.

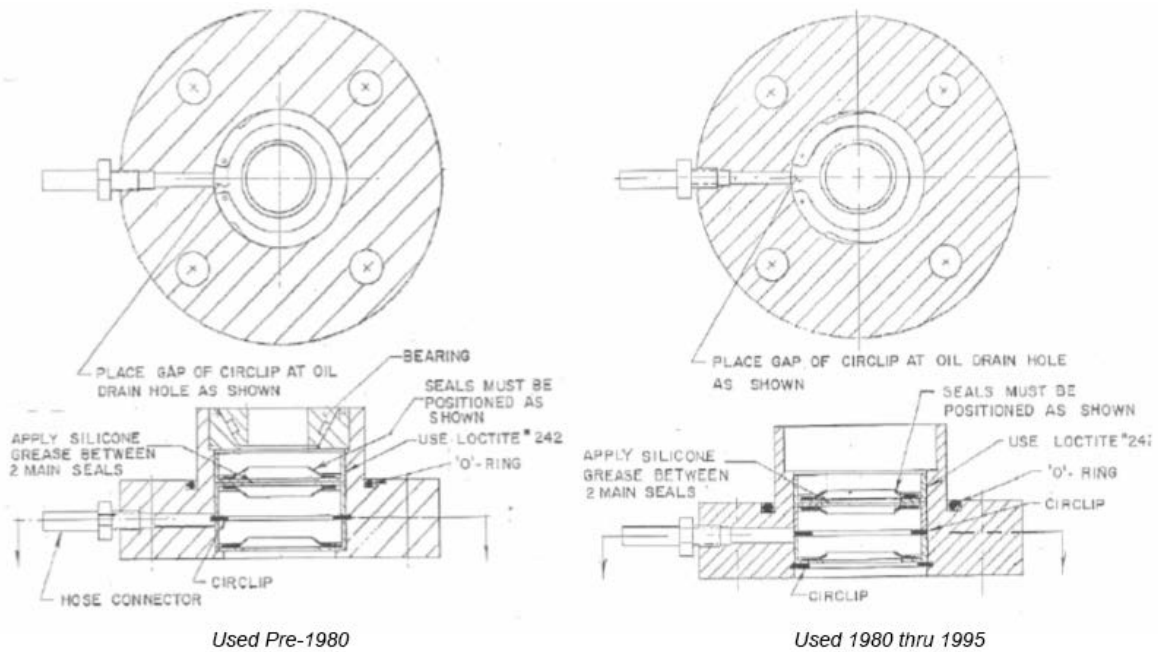
Figure 7 above contains schematics of the two oil seal assembly configurations for the FPE TC Series spring drive mechanisms. When inspecting your FPE TC spring drive mechanism, this is a component that should always be inspected in detail and care should be taken to verify the condition of the oil seal assembly. For the TC-546, the replacement part number is 4000-682. For the TC-525, the replacement part number is 4000-731.

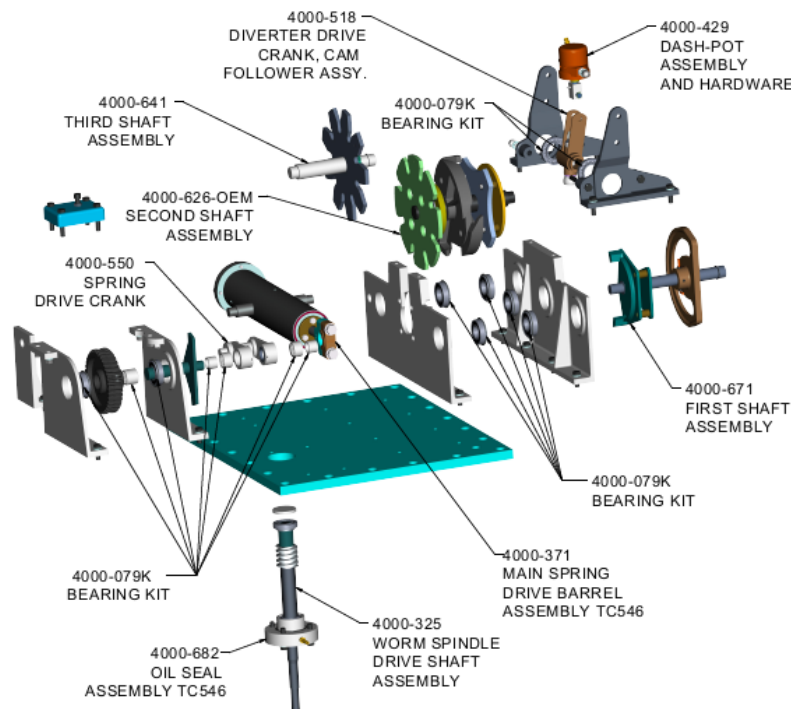
Figure 8: Exploded View of FPE TC-546 Spring Drive Mechanism

If you plan to self-perform tear down, maintenance and repair of your FPE TC Series spring drive mechanism, several key activities should be completed to ensure high quality results. Those key activities are presented in the bulleted list below for a TC-546 spring drive. The list is accompanied by Figure 8 which includes an exploded view of a TC-546 spring drive mechanism. Figure 8 is meant to provide a visual aid to assist in pinpointing and understanding each of the key activities that need to be performed. Key activities include:

- Always replace all bearings (bearing kit, part number 4000-079K)
- Replace the oil seal assembly
- If the 3rd shaft assembly needs replacement, upgrade to the solid Geneva gear design offered by SPX Transformer Solutions Components Group (third shaft assembly, part number 4000-641)
- If the 2nd shaft assembly needs to be replaced, replace with the original Geneva gear design offered by SPX Transformer Solutions Components Group (second shaft assembly, part number 4000-626)
- Replace any gears that have broken teeth or exhibit excessive mechanical wear
- Always fully disassemble and fully inspect the main spring drive barrel assembly (main spring drive barrel assembly for TC-546, part number 4000-371)
- Replace all locking hardware, i.e. lock washers, nyloc nuts, locking tabs and spring pins
